Manhole Inspection Summary

Manhole # S07SS1017MH

Location Address: **3352 AVONDALE AVE**

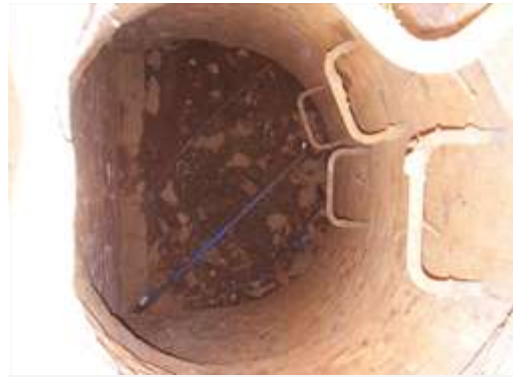
Top View

DEBRIS ON CHANNEL

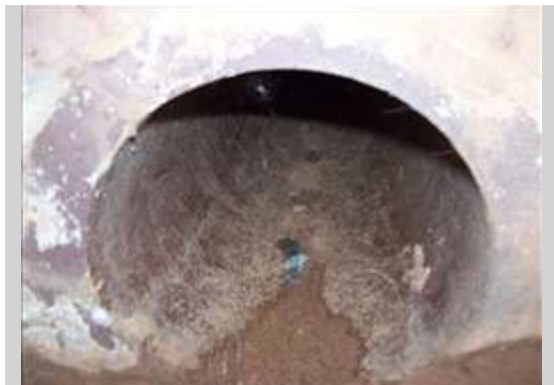
12 O'Clock Outflow

8 in. Circular Gravity Sewer
Pipe Out @ 12 O'Clock

Infiltration: **None** Pipe Seal Cond: **Sound**
